**SUPERIOR COURT OF THE DISTRICT OF COLUMBIA  
CRIMINAL DIVISION—FELONY BRANCH**

**Government’s Motion to Dismiss the Indictment**

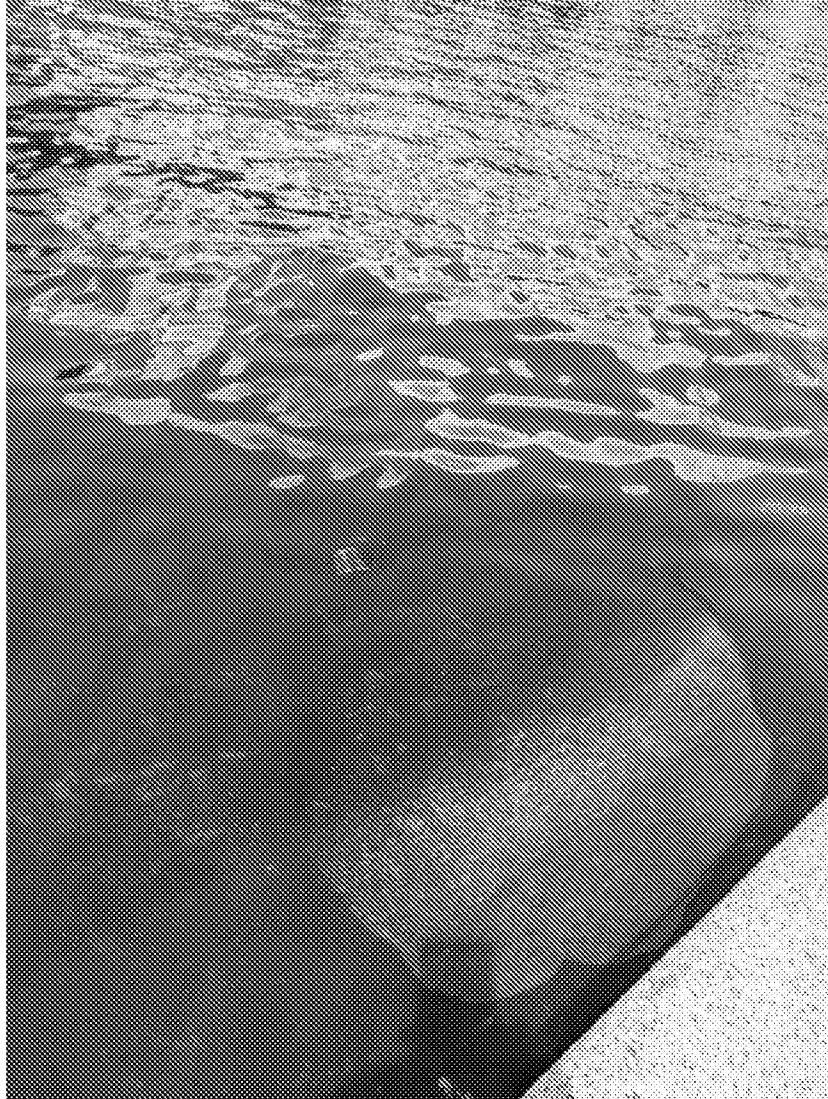
A third NPS employee, W-3, took a photograph of the area where the defendant was seen pulling the lining prior to the incident involving the defendant. Metadata associated with the photo indicates that it was captured at 2:55 PM on July 19, 2026, shortly before W-1 and W-2 observed the defendant aggressively pulling and further damaging this compromised are of the Reflecting Pool.

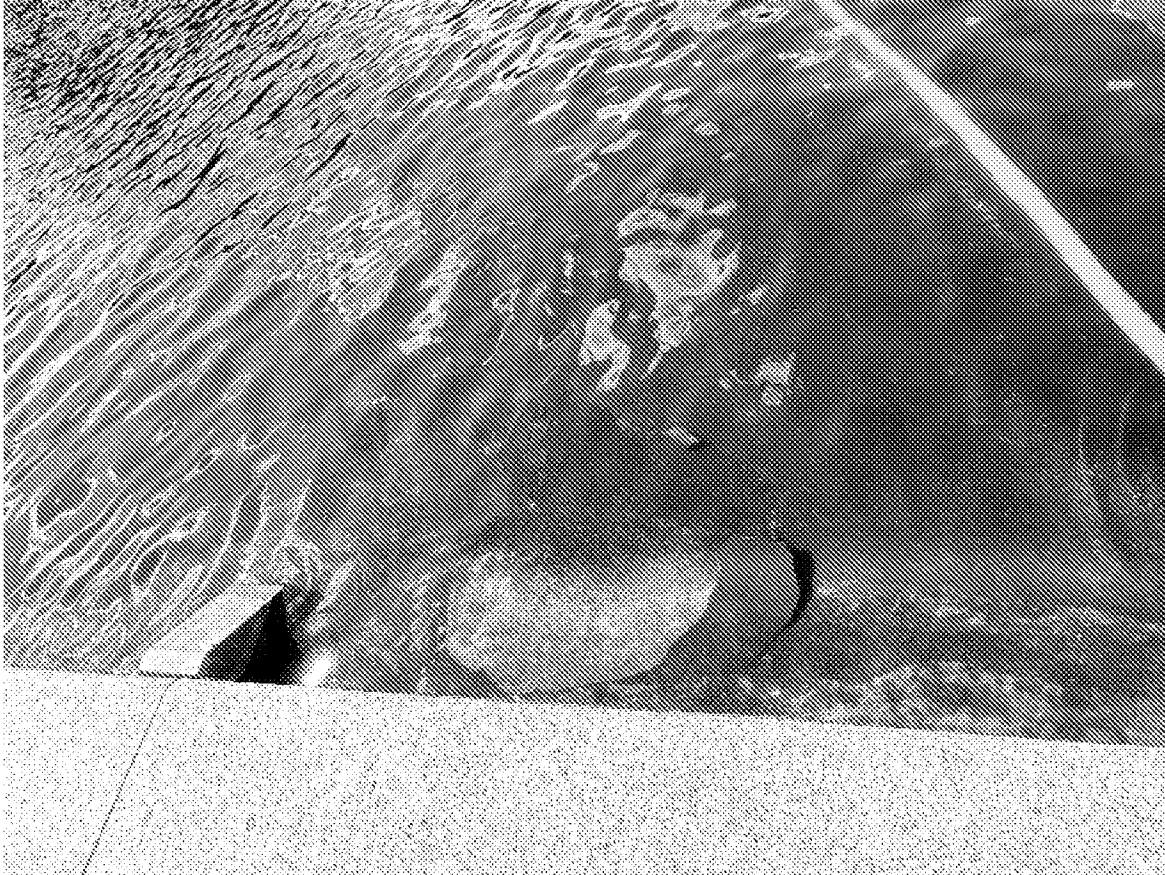
The photograph below was taken by NPS employee W-1 after the incident involving Hearn. Metadata associated with the photo indicates that it was captured on June 19, 2026, at 4:48 PM. A review of USPP body-worn camera shows the officers speaking with the defendant at 4:40 PM.

W-4, an employee specializing in maintenance and repairs employed by the National Park Service, stated that repairing the additional damage caused to the reflecting pool based on the defendant's conduct would cost over \$1000. DOI represented that nearly all of the damage to the Reflecting Pool was due to vandalism with only a small portion due to unidentified other causes.

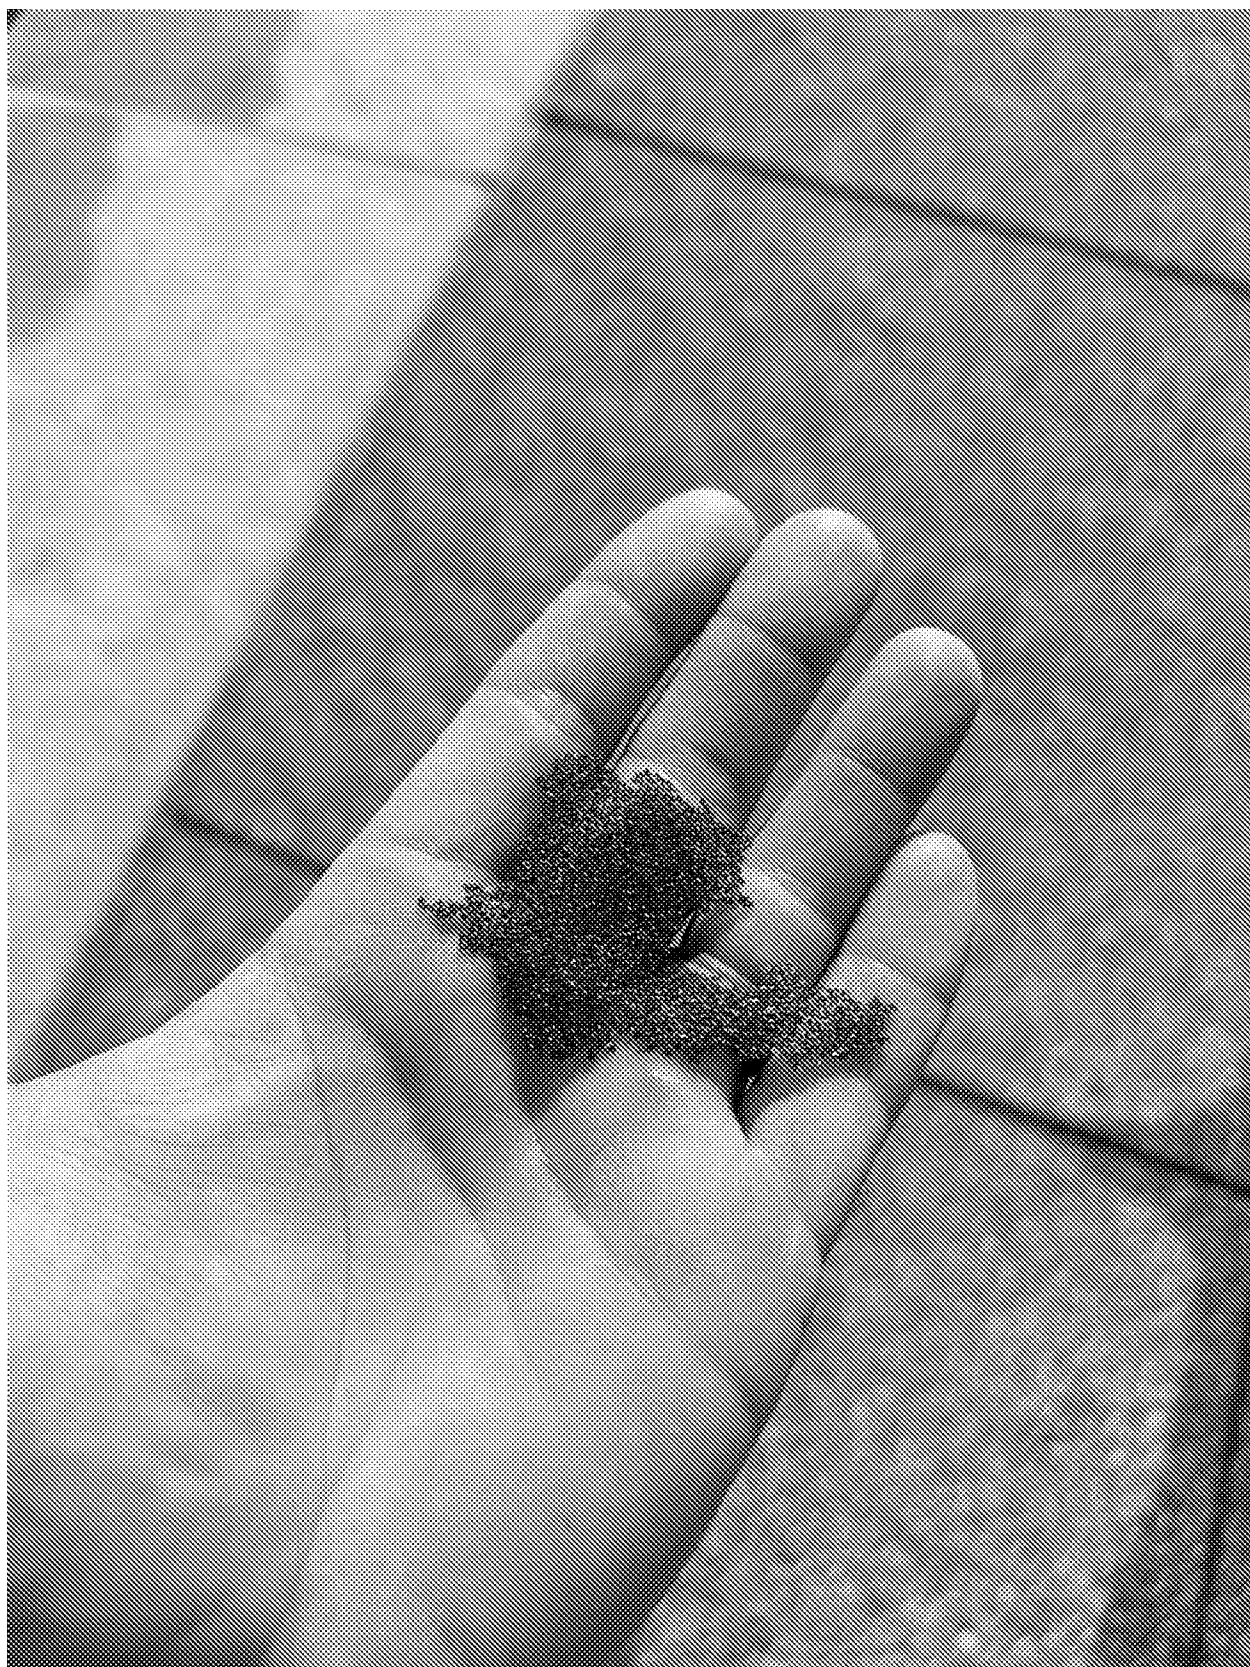
- Only the top layer of liner has peeled. This is very thin and will not impact the strength of the liner.
- The color underneath the peeled area is still dark, “American Flag” blue.
- The total peeled area is small, less than 1 square foot and noncontinuous.
- The contractor stated that the peeled area was “overspray” from spraying the perimeter joint with polyurea.
- I stated my concern that this “overspray” along the perimeter of the pool could lead to a 1’-2’ strip that is vulnerable to peeling. The contractor would not confirm in field if this was or wasn’t a risk.
- The polyurea liner that has peeled does not float in water, so should not be highly visible to visitors and can be vacuumed out along with sediment and algae during the normal cleaning process.
- I walked the perimeter of the pool and did not identify any additional peeling areas.

Notably, the engineer’s email recounted AIC’s explanation that peeling areas around the perimeter were “overspray” and that a one-to-two-foot strip was vulnerable to peeling. This was the area along the perimeter that the defendant is alleged to have pulled up. He also stated that the liner that has peeled does not float in the water and that peeling “will not impact the strength of the liner.” The engineer provided photographs of the peeling area:

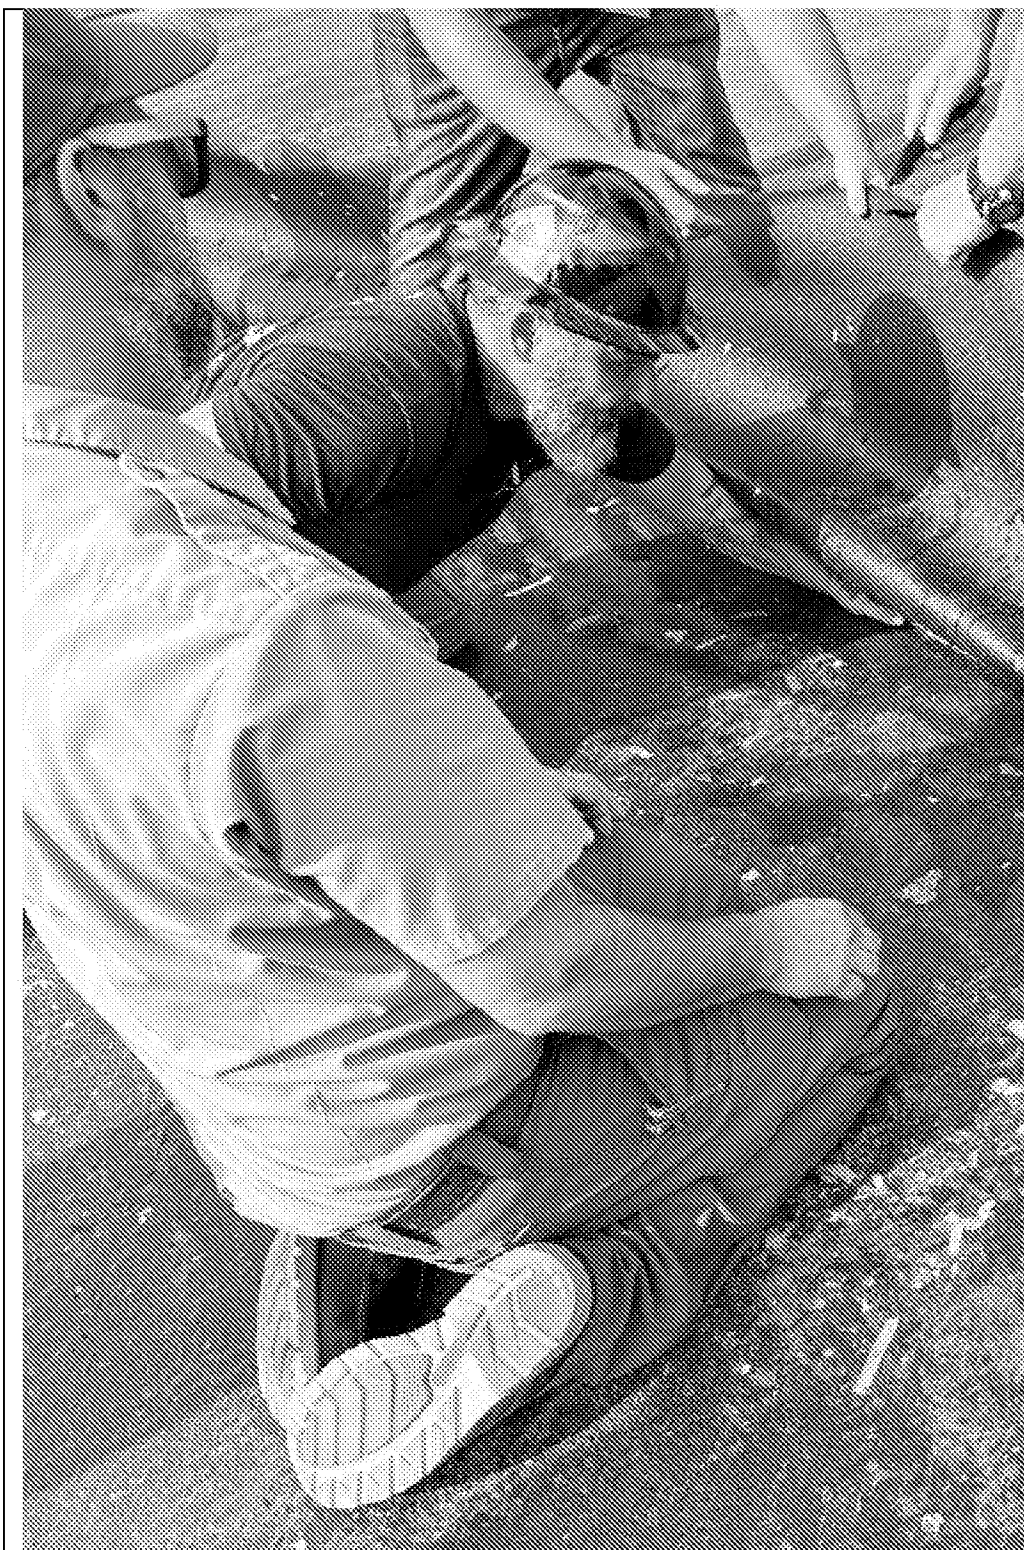
2. Each of the coating failures along the perimeter of the pool (most noteworthy in Bays 04, 06, 07 and 09) were examined in detail. Various theories were discussed as to the cause of the failures in the interface between 11-35 and Pipeliner 5000. An apparent cause of failure may be the application of too little or too much XP bonding agent.
3. At each coating failure along the perimeter, [REDACTED] of AIC proposed the following remediation: remove all existing failed material as required until firmly adhered material is encountered, power wash the exposed area to clean the substrate; grind/abrade the substrate; apply XP bonding agent; apply 11-35, apply Pipeliner 5000 for texture.
4. Many areas were observed where Pipeline 5000 was applied for texture over 11-35 and oversprayed onto existing Pipeliner 5000 and hence had not bonded. This loose material can be removed by powerwashing.

Photo #5 – Examination of delaminated coating at tranverse expansion joint between Bays 04 and 06

Although “[v]arious theories were discussed as to the cause of the failures,” overspraying and a failure of the coatings to bond predominate in the report. Three days of repairs were estimated by AIC to address the issues identified. Photographs from the report show the extent of damage to the pool caused by over spraying and delamination. Damage was noted throughout the Reflecting Pool, and not just at the perimeter.
